DELAWARE VALLEY WORKS FACILITY  
INTERIM REMEDIAL MEASURE COMPLETION REPORT  
UPPER SLUICeway CLEANOUT  
CLAYMONT, DELAWARE

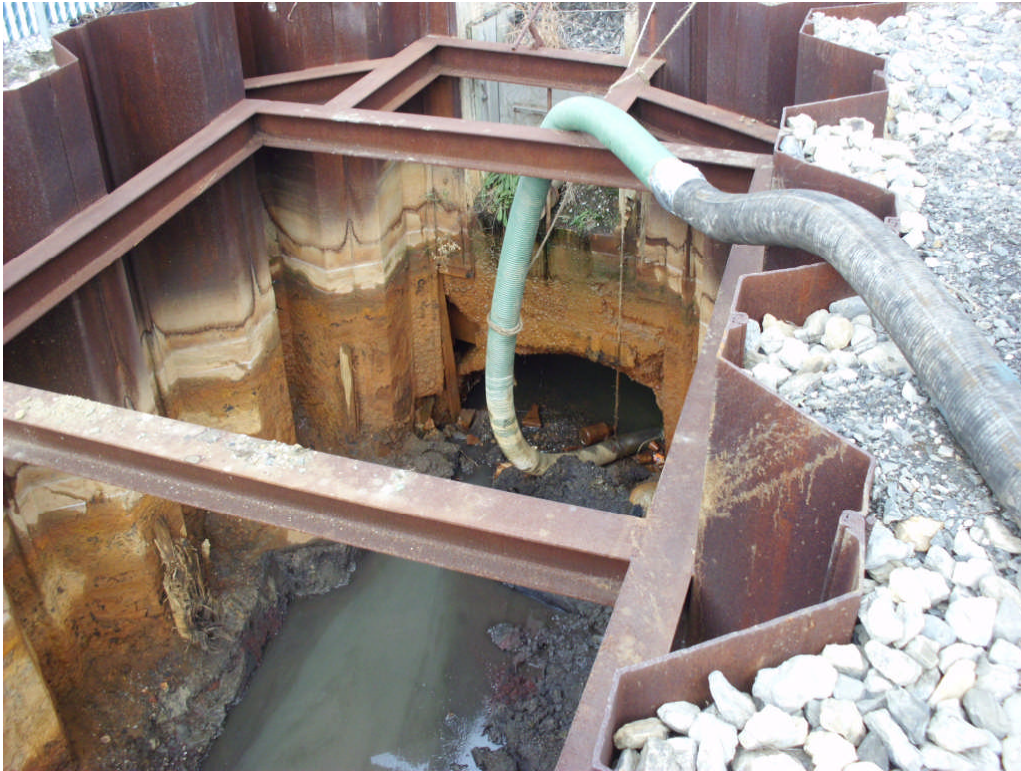
View of the downstream end of the subsurface concrete pipe and the dewatering of the pipe.

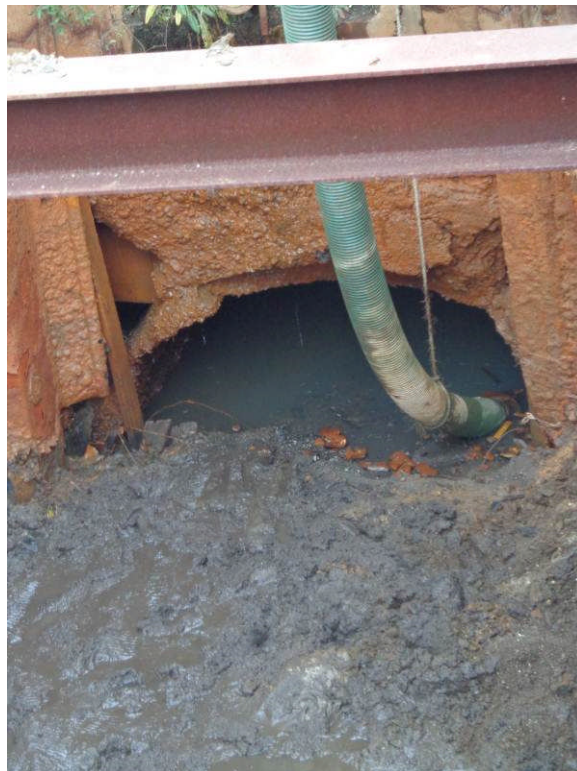
View of the downstream end of the subsurface concrete pipe and the dewatering of the pipe.

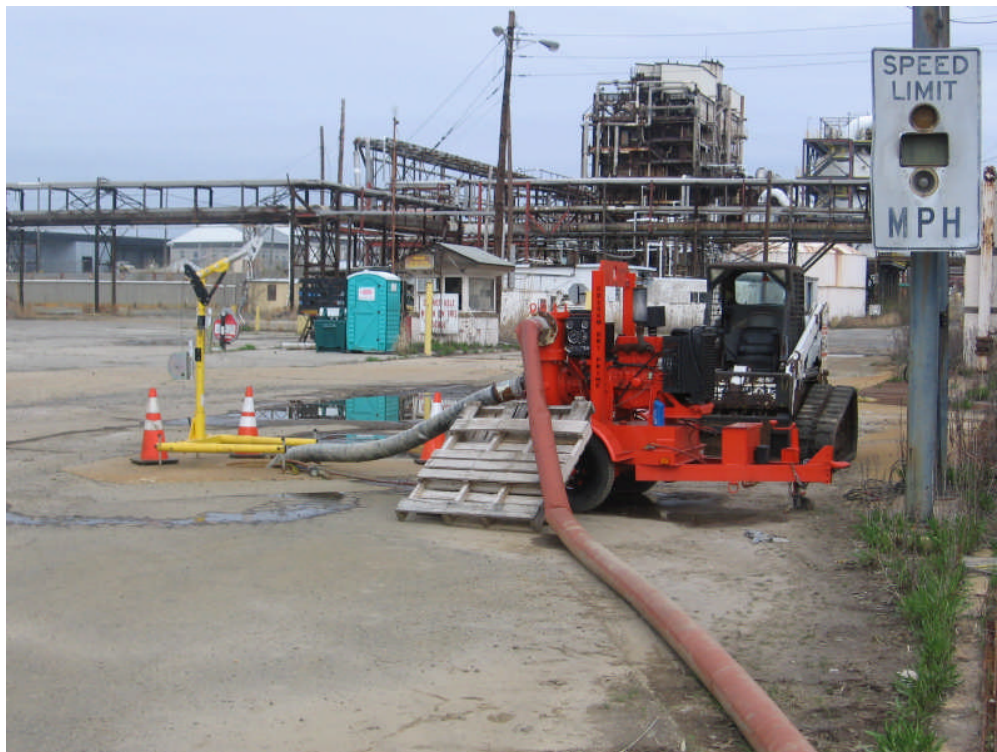
View of the pump diverting water from a manhole located upgradient of the confluence box.

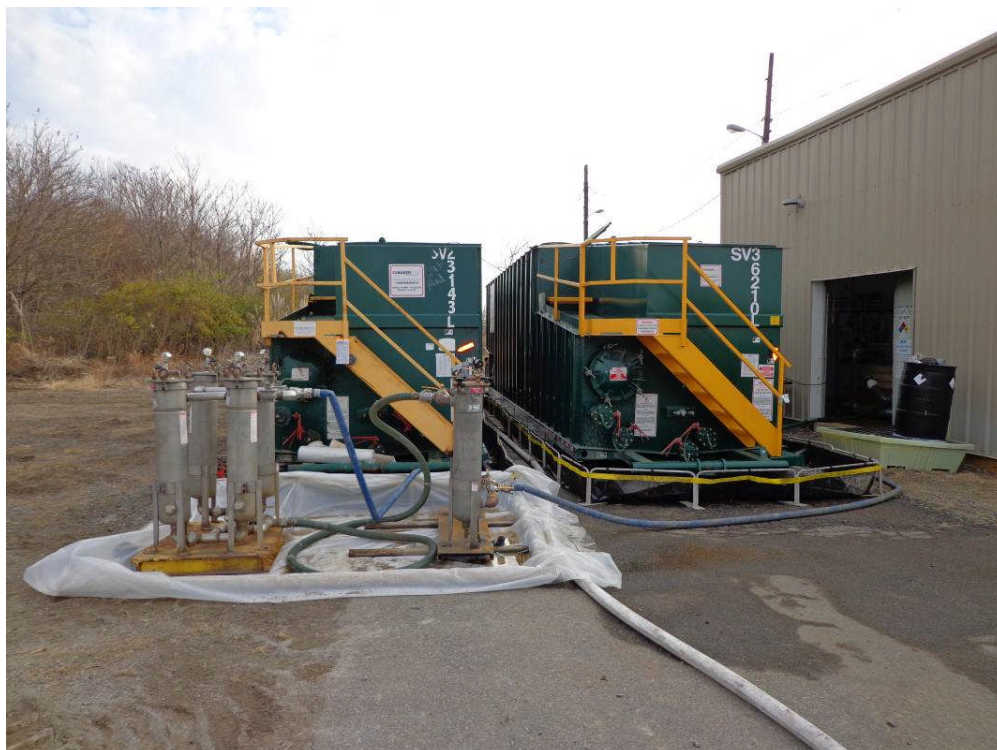
View of the inline filter system and the frac tanks used to treat and store the diverted water before being pumped into the water treatment building.

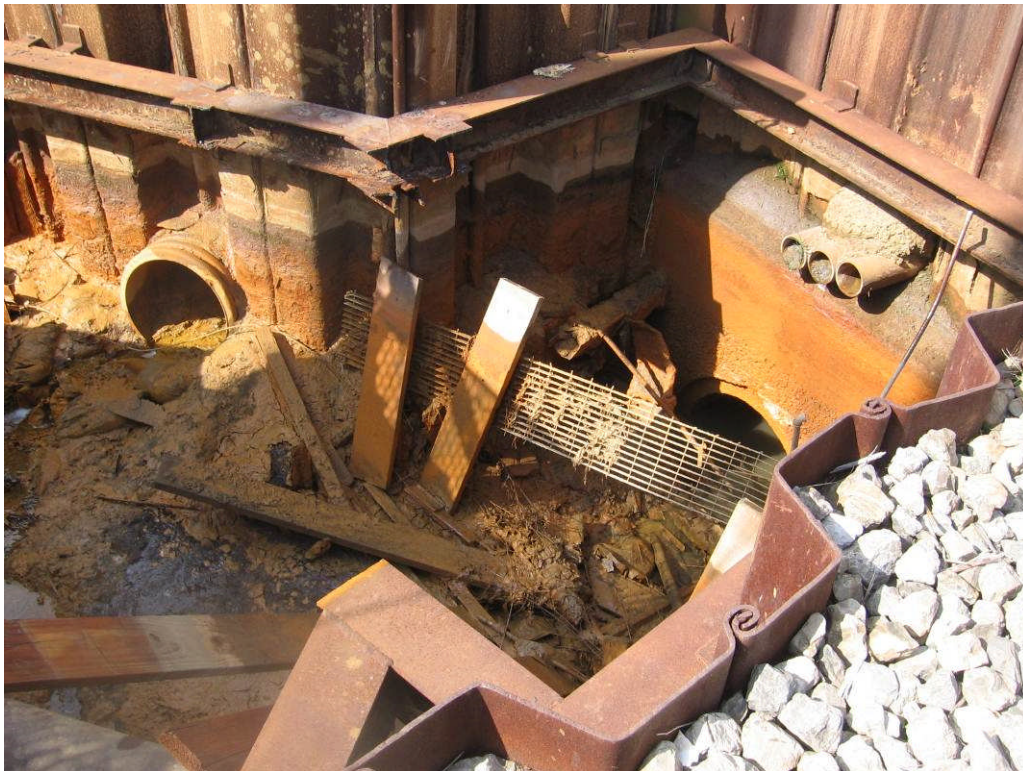
View of debris in front of the confluence box inlet pipes.

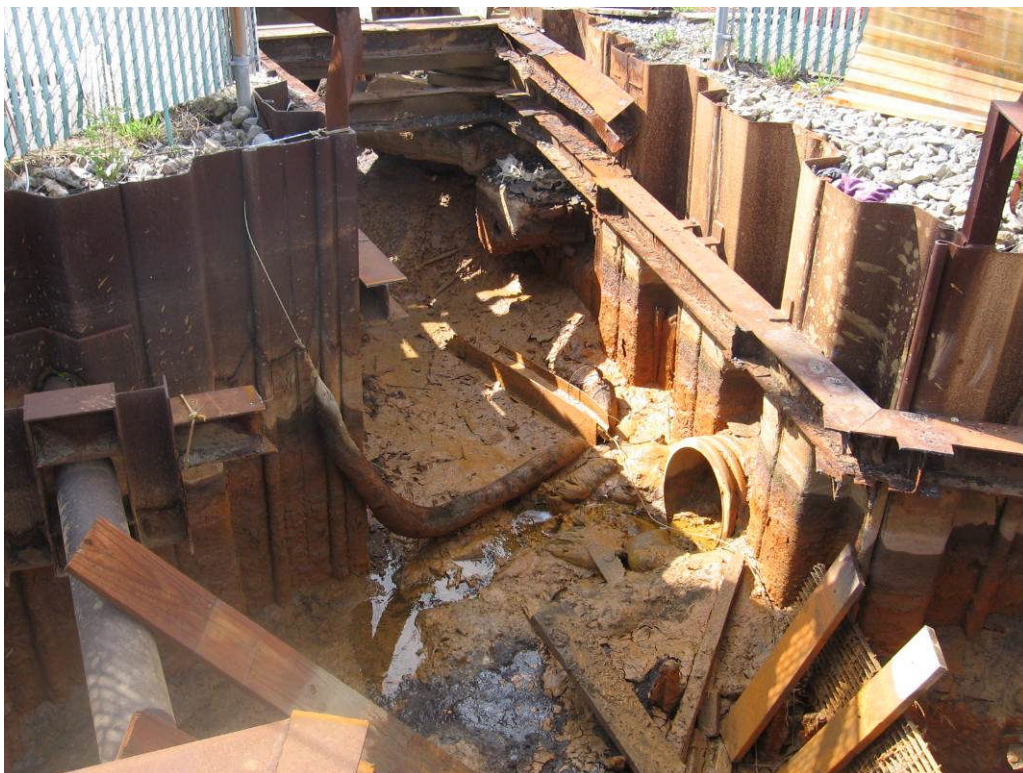
View of debris in front of confluence box inlet pipes.

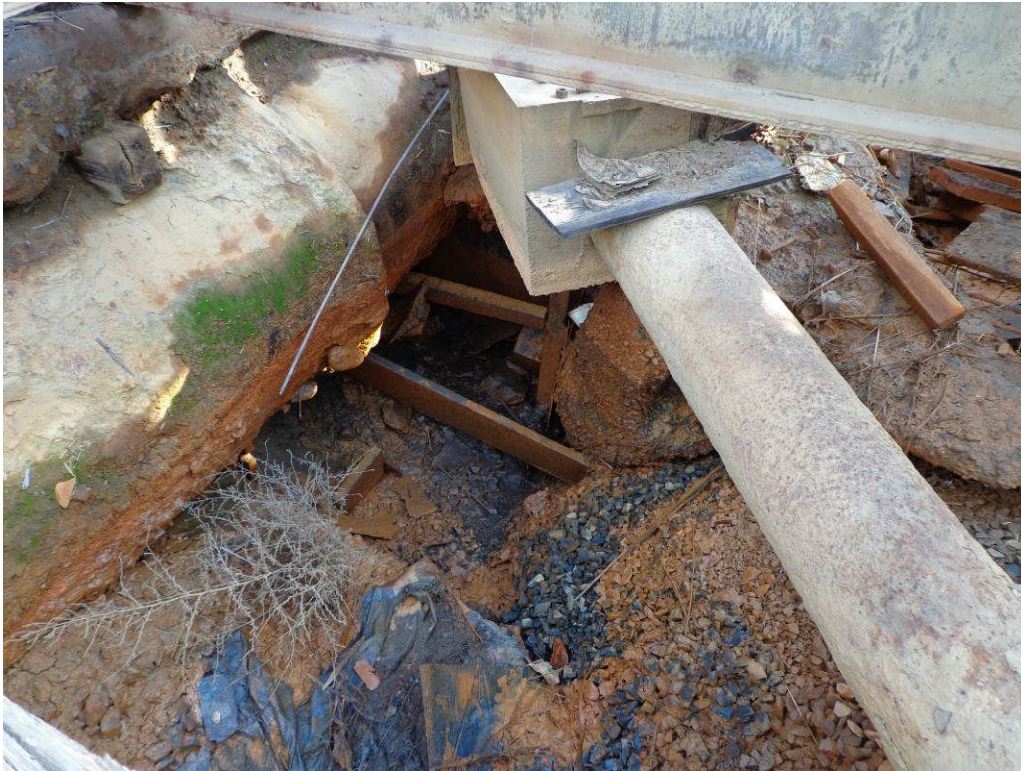
View of the debris under the railroad track between the confluence box and the subsurface concrete pipe.

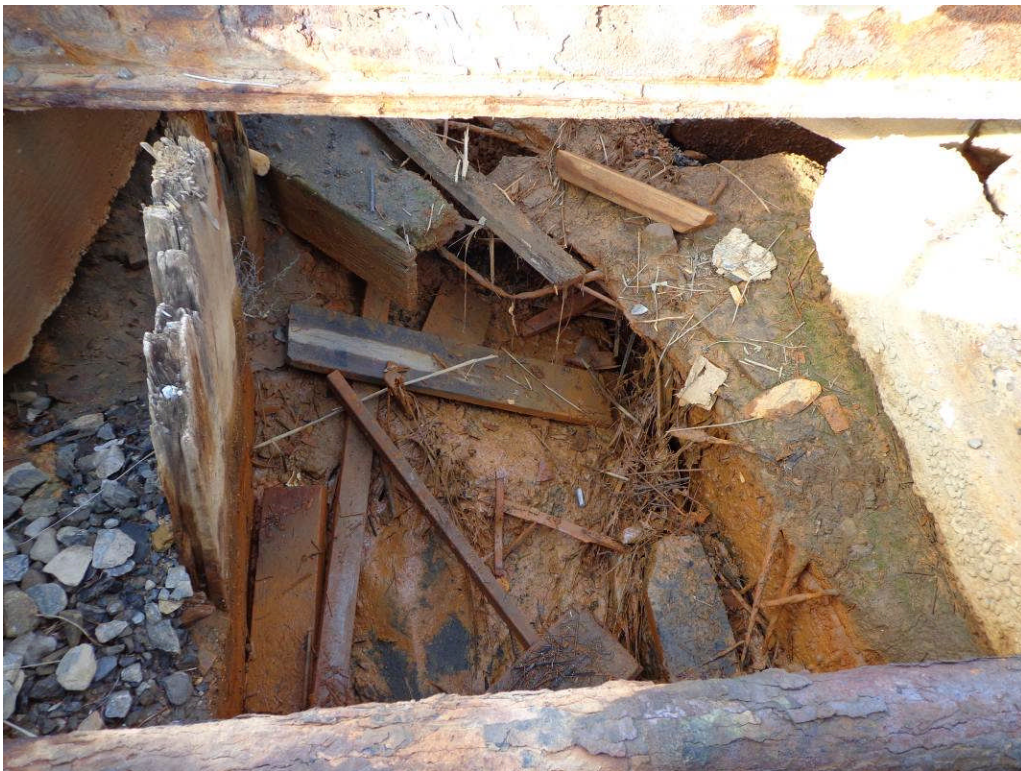
View of the debris under the railroad track between the confluence box and the subsurface concrete pipe.

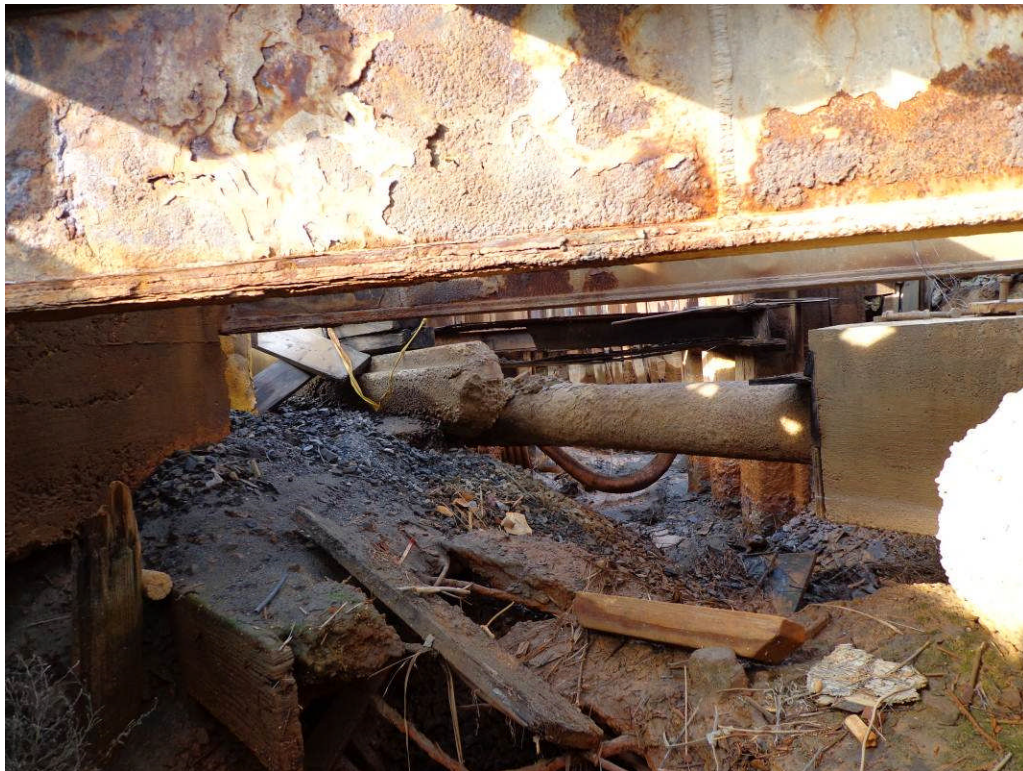
View of the debris under the railroad track between the confluence box and the subsurface concrete pipe.

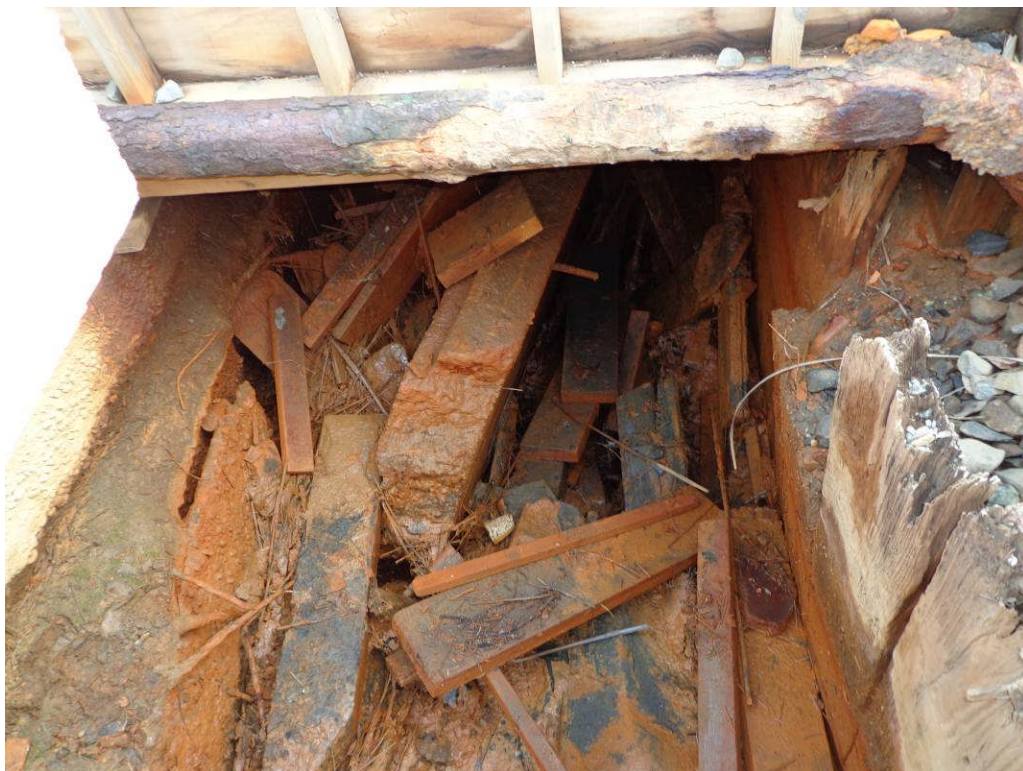
View of the debris pile at the upstream entrance of the subsurface concrete pipe.

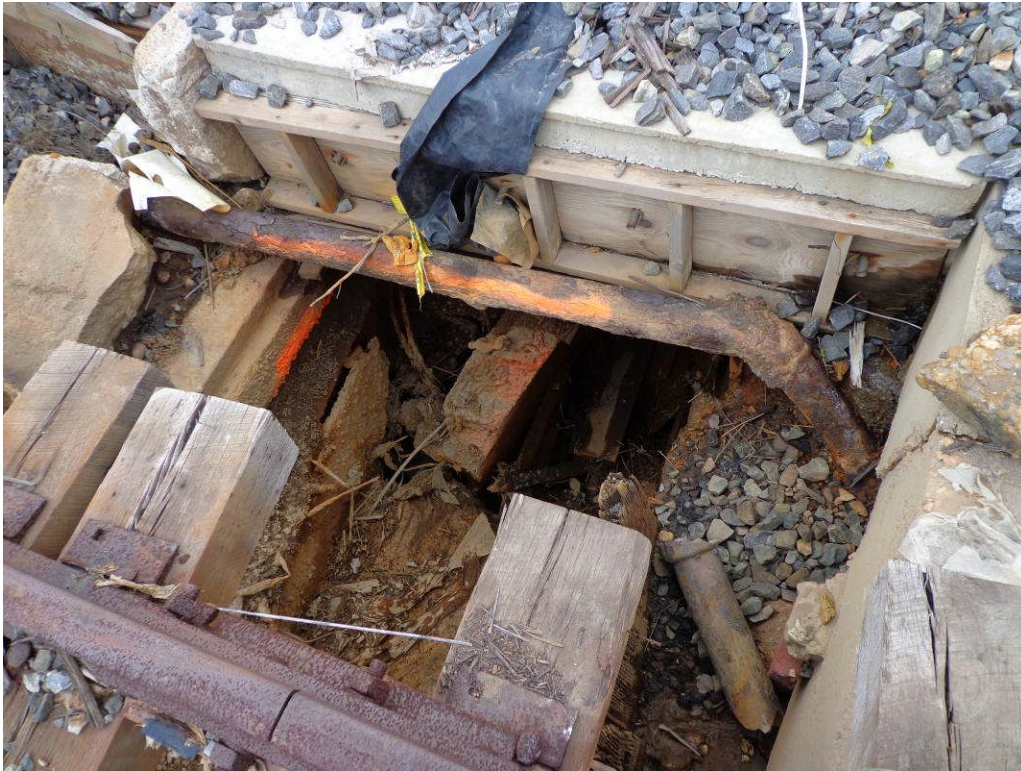
View of the debris pile at the upstream entrance of the subsurface concrete pipe.

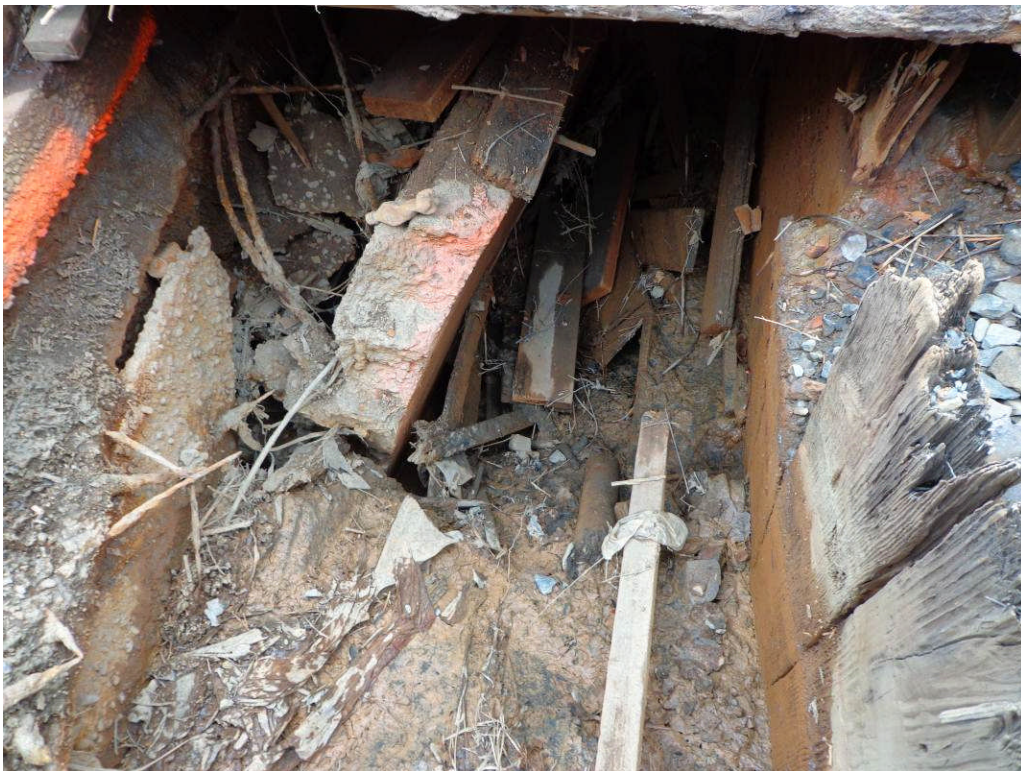
View of the debris pile at the upstream entrance of the subsurface concrete pipe.

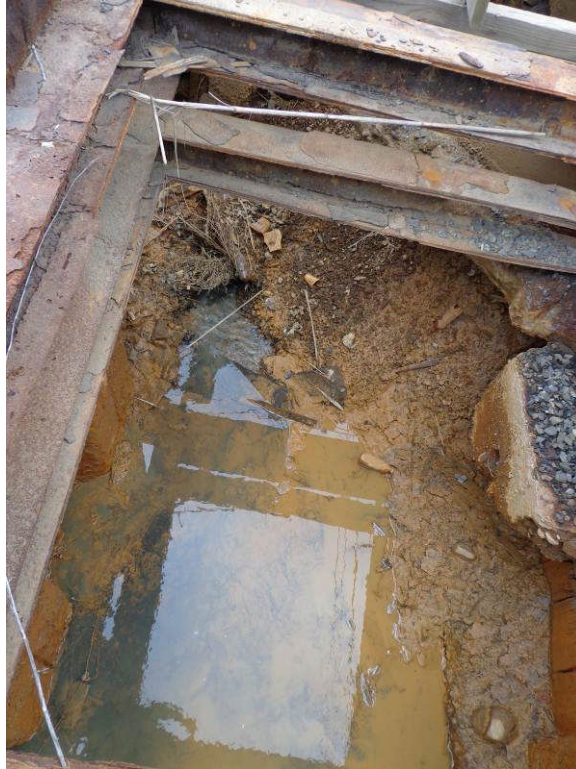
View of water flowing past the debris pile and entering the subsurface concrete pipe.

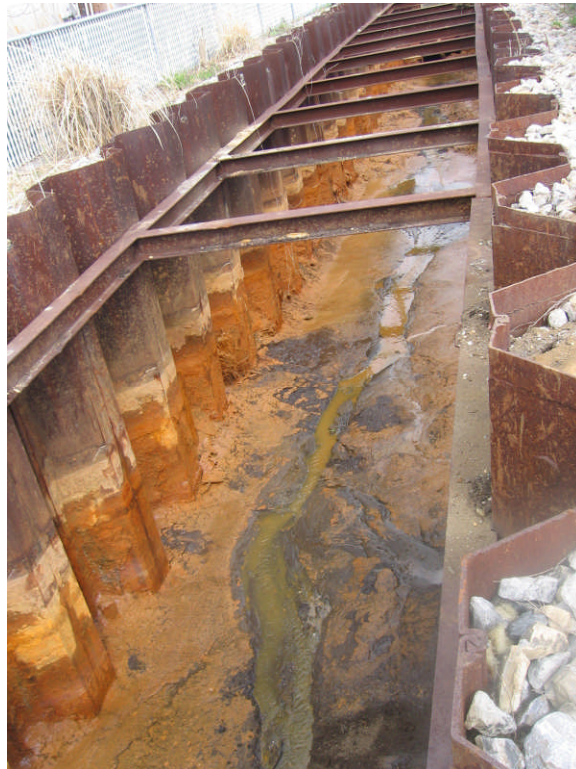
View of the dewatered upper sluiceway.

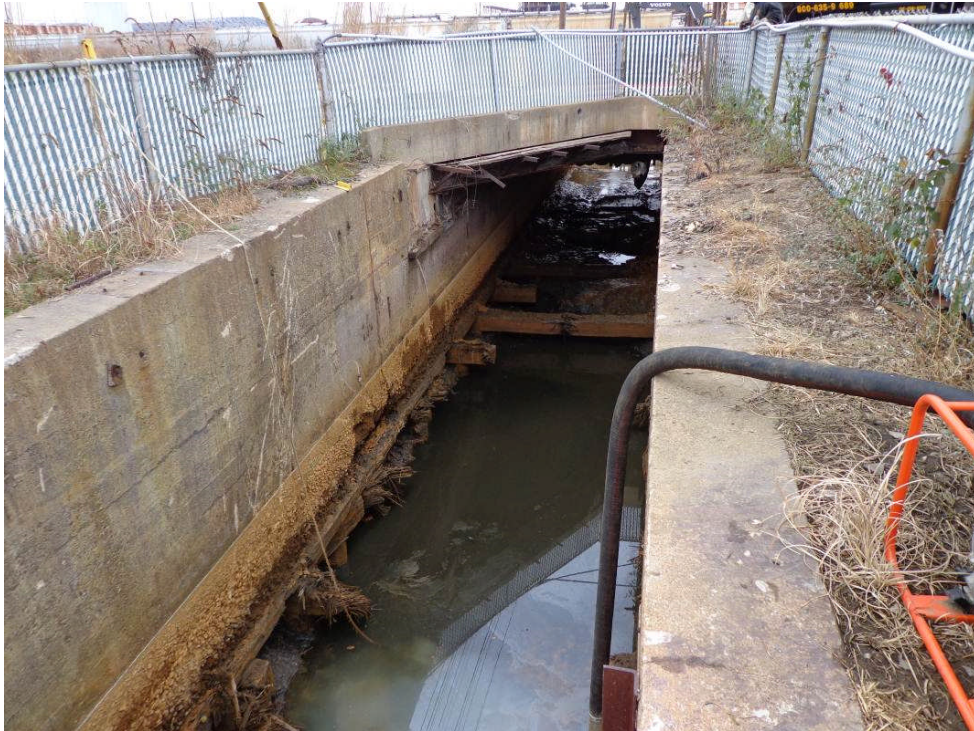
View of the wooden cross beams under the concrete roadway.

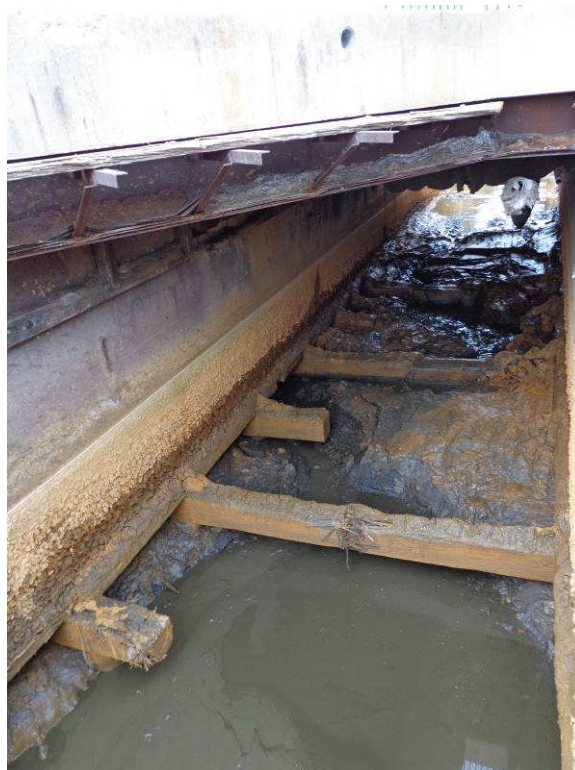
View of the wooden cross beams under the concrete roadway and sediment not yet stabilized with the Super Absorbent Polymer (SAP).

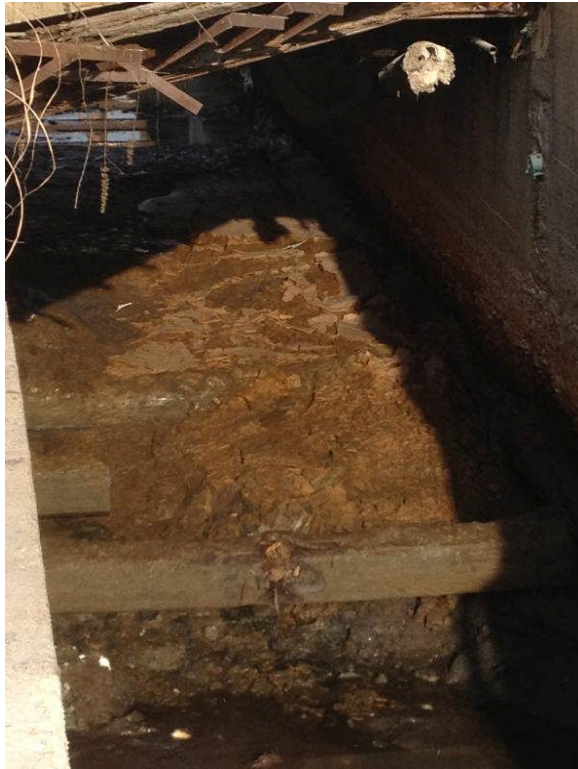
View of wooden cross beams under the concrete roadway and sediment not yet stabilized with the SAP.
